THE RECOVERY, RECONSTRUCTION, AND ANALYSIS OF YENİKAPI 14 (YK
14), A MIDDLE BYZANTINE MERCHANT SHIP FROM THE THEODOSIAN
HARBOR EXCAVATIONS AT YENİKAPI, ISTANBUL

A Dissertation

MICHAEL RICE JONES

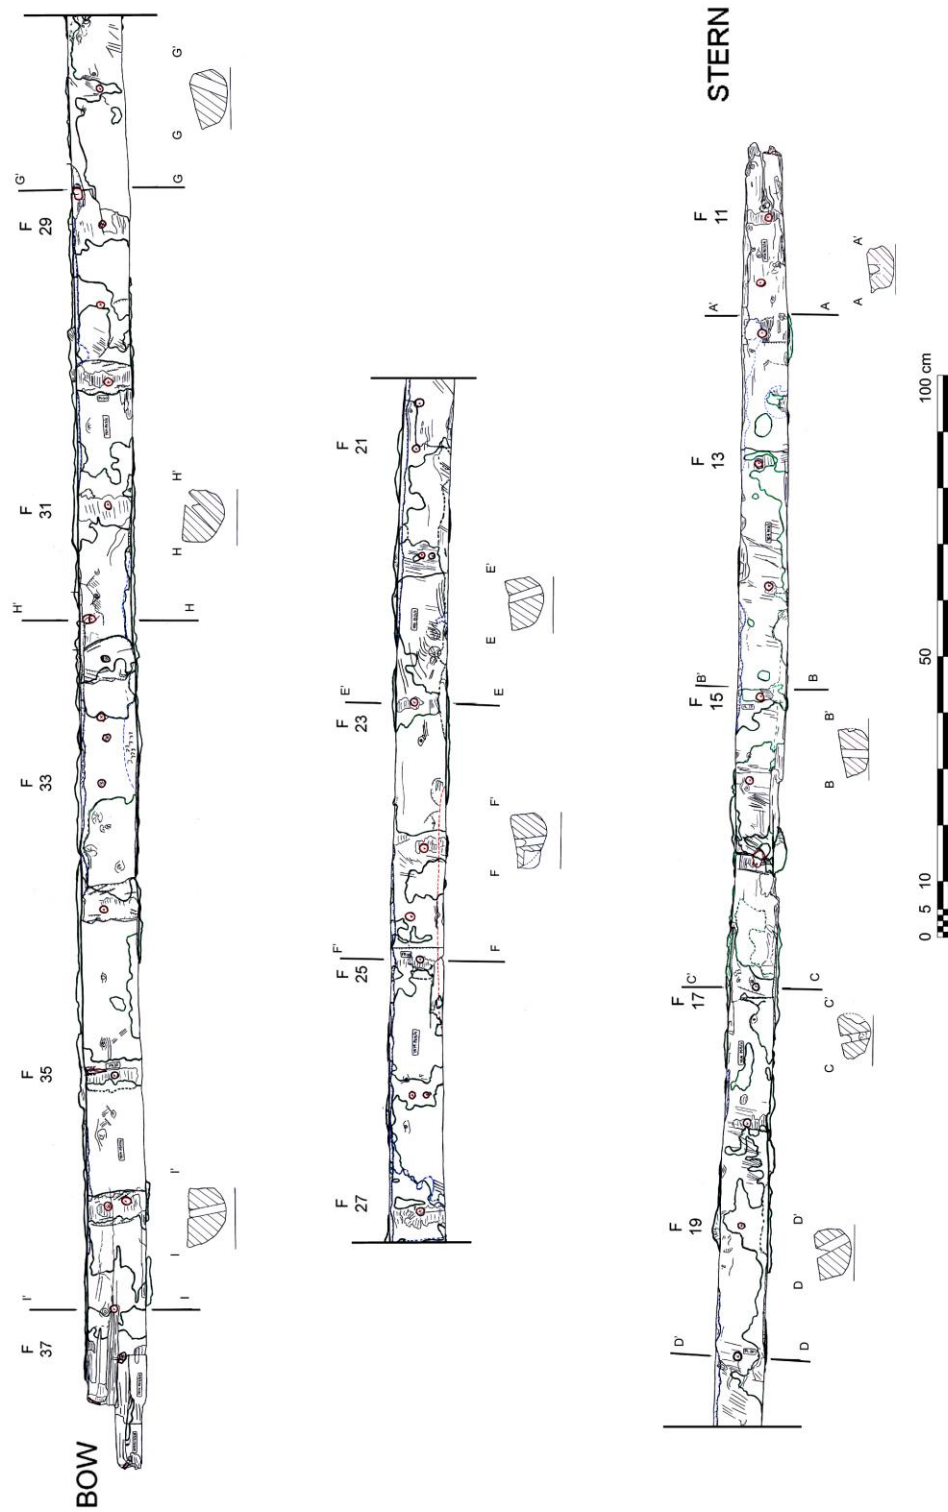
Figure 3.110: Inner face and cross sections of whale PS 13.

PS 13 is the only wale timber recovered from YK 14, surviving to an approximate length of 6.91 m. The wale was cut from a single straight oak log of *Quercus cerris* and bisected with a saw; all of the faces of the timber were further worked with an adze. Flat sections were cut on the upper and lower edges of the wale to accommodate the adjoining strakes. Both ends were broken during or soon after the ship's sinking (**Figure 3.110**). The wale's width ranges from 8.0 to 10.45 cm, and its thickness ranges from 3.6 to 7.15 cm; the timber has a gradual taper, with the wider end placed towards the forward end of the hull. The original surfaces of the wale timber were found to be in

very good condition, due in large part to the thick pitch layer on the outboard surface of the timber, which ranged in thickness from 0.5 cm up to 1.5 cm in most areas near the plank seam. Areas of wood-rot damage along the lower edge and outer face of the wale between frames 15-16 and frames 23-26 were repaired with generous amounts of pitch; in one area around FL 16, where a deep depression was cut into the wale (perhaps to remove a rotten area?), the pitch deposits were up to 2.3 cm thick.³⁵⁶

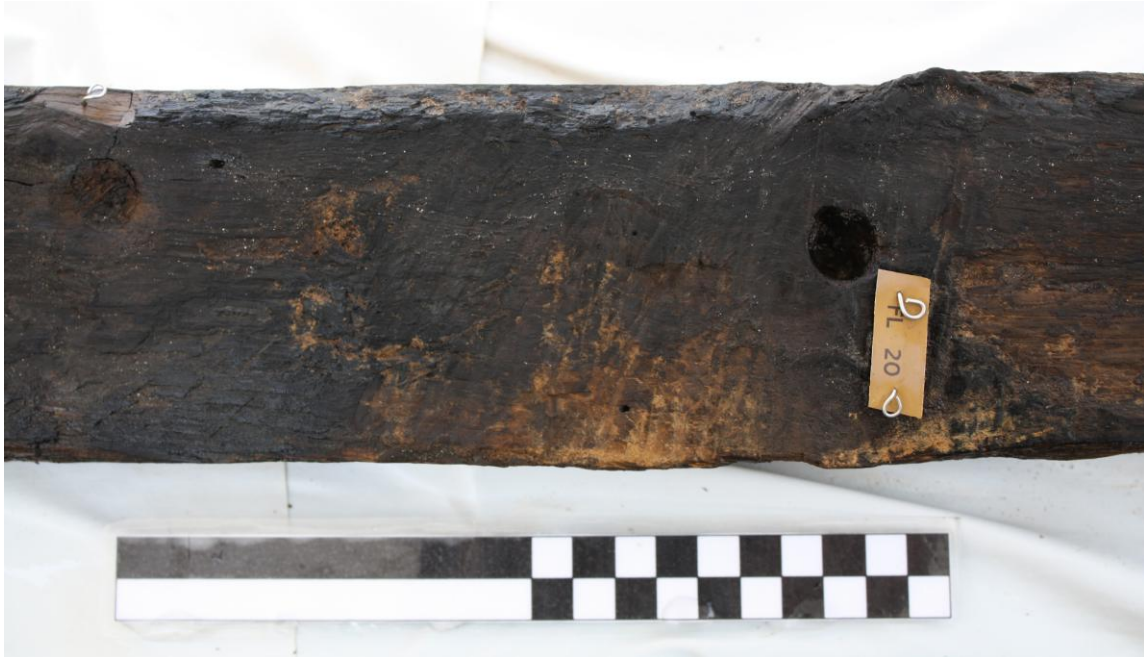
Figure 3.111: Charred area on wale PS 13's inner face; note the rough upper edge.

Charred areas of the wale are concentrated on the upper part of the inner face, small sections of the lower edge, and lower section of the inner face (**Figure 3.111**).

Blackened sections of the inner face occur between FL 32-33, 15-16, and at F 27, although some of these areas could be darkening of the wood from iron sulfide staining rather than deliberate charring. Charring was also apparent on the inner faces of oak wales from other ships excavated at Yenikapı, including YK 1, 5, 11, and (possibly) 23.

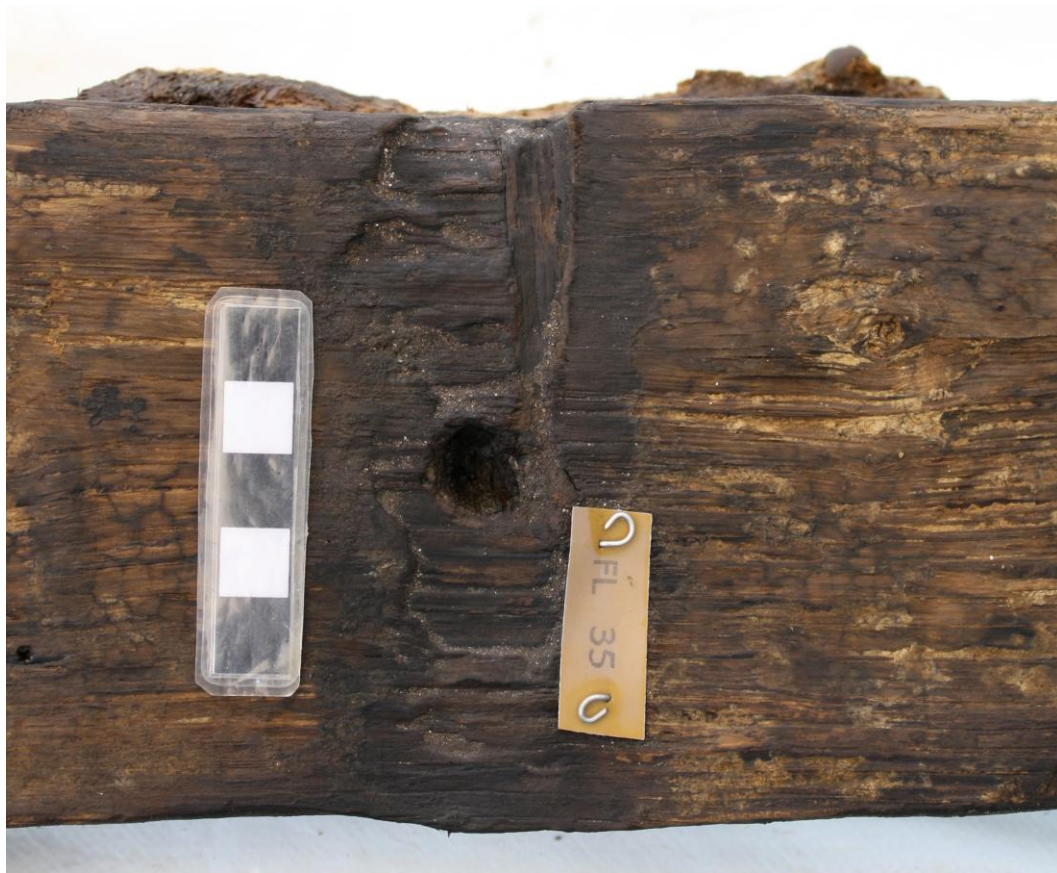
Figure 3.112: The inboard half of a coak for fastening the forward scarf end of plank PS 14-2/2-6 is exposed at a futtock location on the inner face of wale PS 13. This is the only coak found driven into PS 13.

Several features of wale PS 13 indicate that it is the first timber in the outer hull planking to be installed 'frame-first'. Firstly, PS 13 is the lowest original strake in the hull without regularly spaced coaks fastening it to adjoining strakes. There is only a single coak found on the wale, which was used to fasten the diagonal aft scarf end of PS 14-2/2-6 to the upper edge of the wale (**Figure 3.112**).

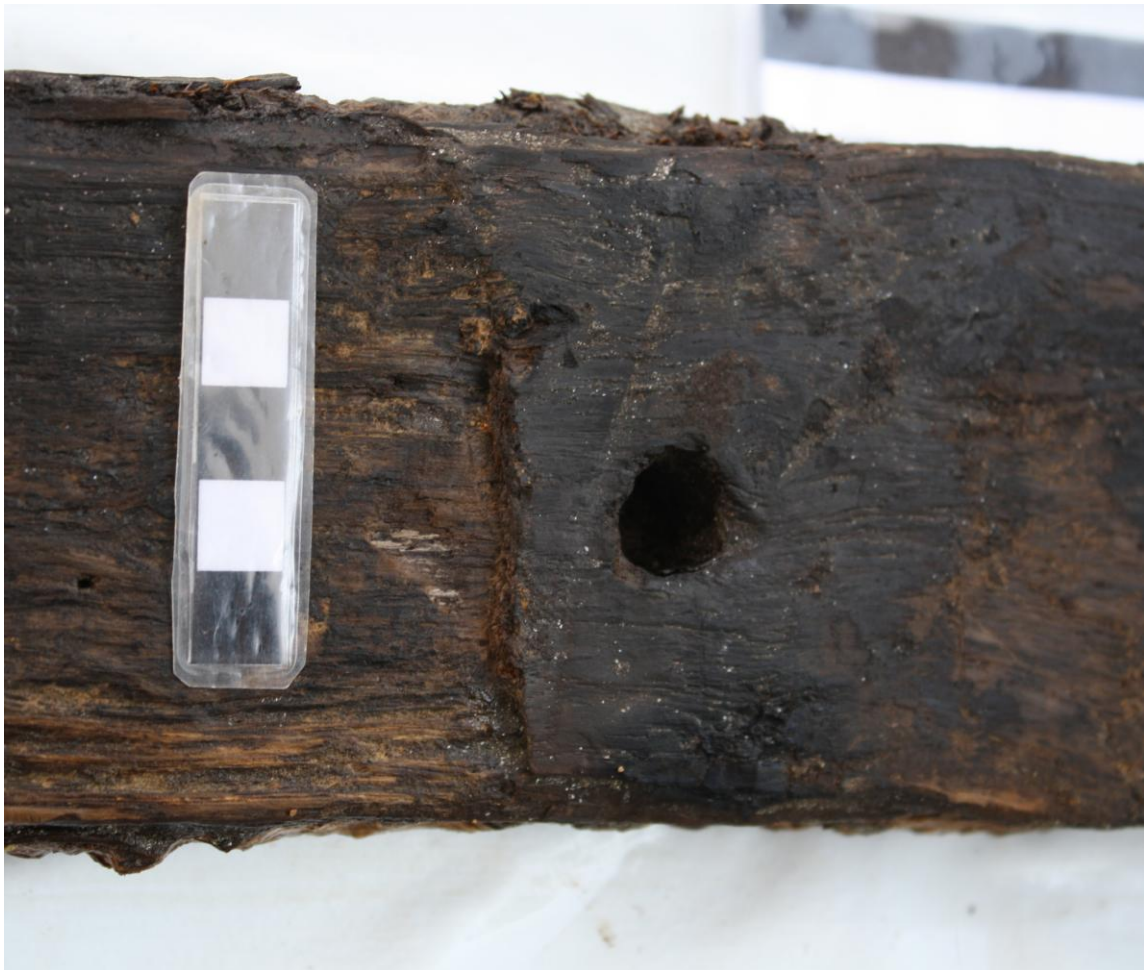
Figure 3.114: A cut at a raised area on PS 13 at the location of F 17.

Secondly, cut depressions occur on the inner face of the wale at the locations of floors FL 36, 34, 32, and 30, while raised areas were cut at the locations of frames FL 20, F 19, FL 18, and F 17, an indication that these floor timbers were already in place when the wale was being shaped and bent around these frames in a specific way (**Figures 3.113-14**). Similar raised areas also occur on the next strake, PS 14-1, at FL 12 and FL 14. The reason for these raised areas is unclear, but may relate to an attempt to thin the wale timber to increase its flexibility while also avoiding a gap between the frames and the

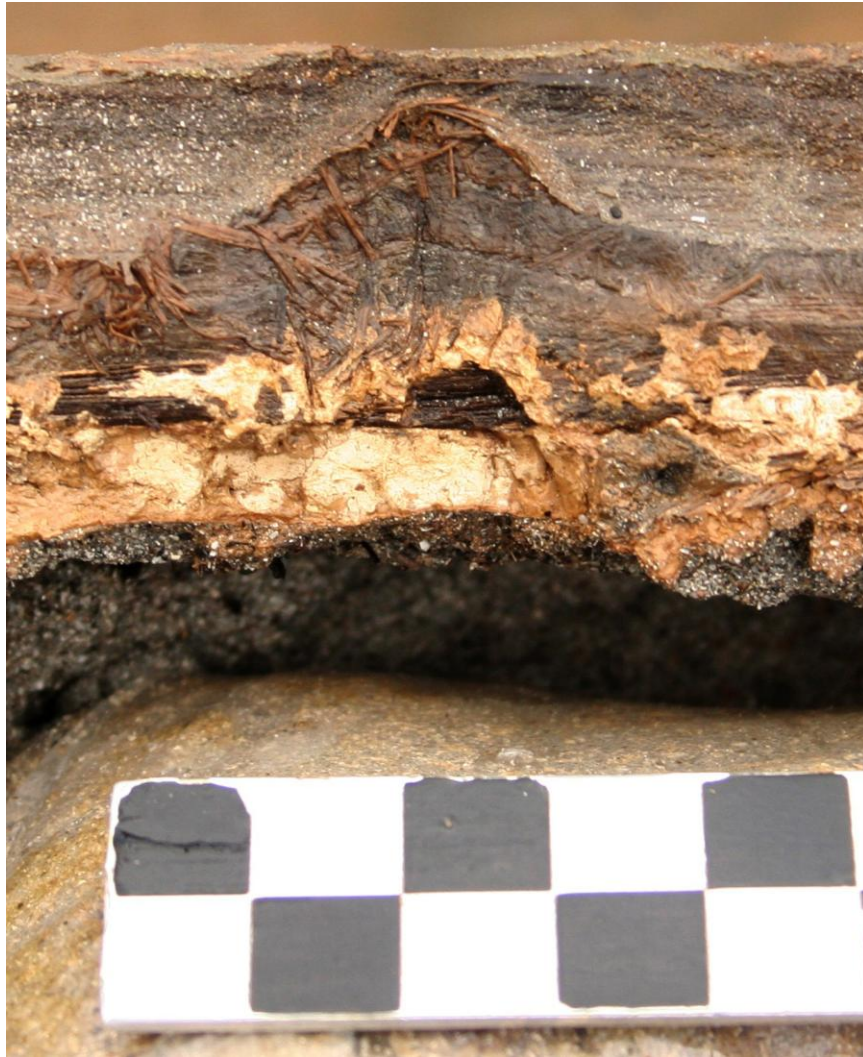
Figure 3.116: Detail of the notch in the upper edge of PS 12-1 at the location of FL 26. Note the caulking adhering to the surfaces of the notch.

Thirdly, on the upper edges of strakes PS 12 and PS 12A, directly below the wale, small, caulked-over notches were cut adjacent to thirteen floor timbers at FL 12, 14, 16, 18, 20, 22, 24, 26, 28, 30, 32, 34, and 36 (**Figures 3.115-17**). The notches are 0.3-1.0 cm deep, and are spaced between 41.8 and 56.2 apart, center to center, with an average spacing of 46.9 cm; however, the spacing varied sufficiently to suggest that they were not positioned precisely using a specific length standard. The widest and deepest parts of the notches are along the outboard edge of the hull planks. Tool marks were clearly evident

in the notches, so there was no question of their being a result of rot or other damage. Their average maximum depth is 0.6 cm, although several were cut up to 0.7-1.0 cm deep. Each notch had been filled with pitch and caulking. The notches vary in shape, but most are roughly triangular or trapezoidal, and were likely cut with an adze or chisel.

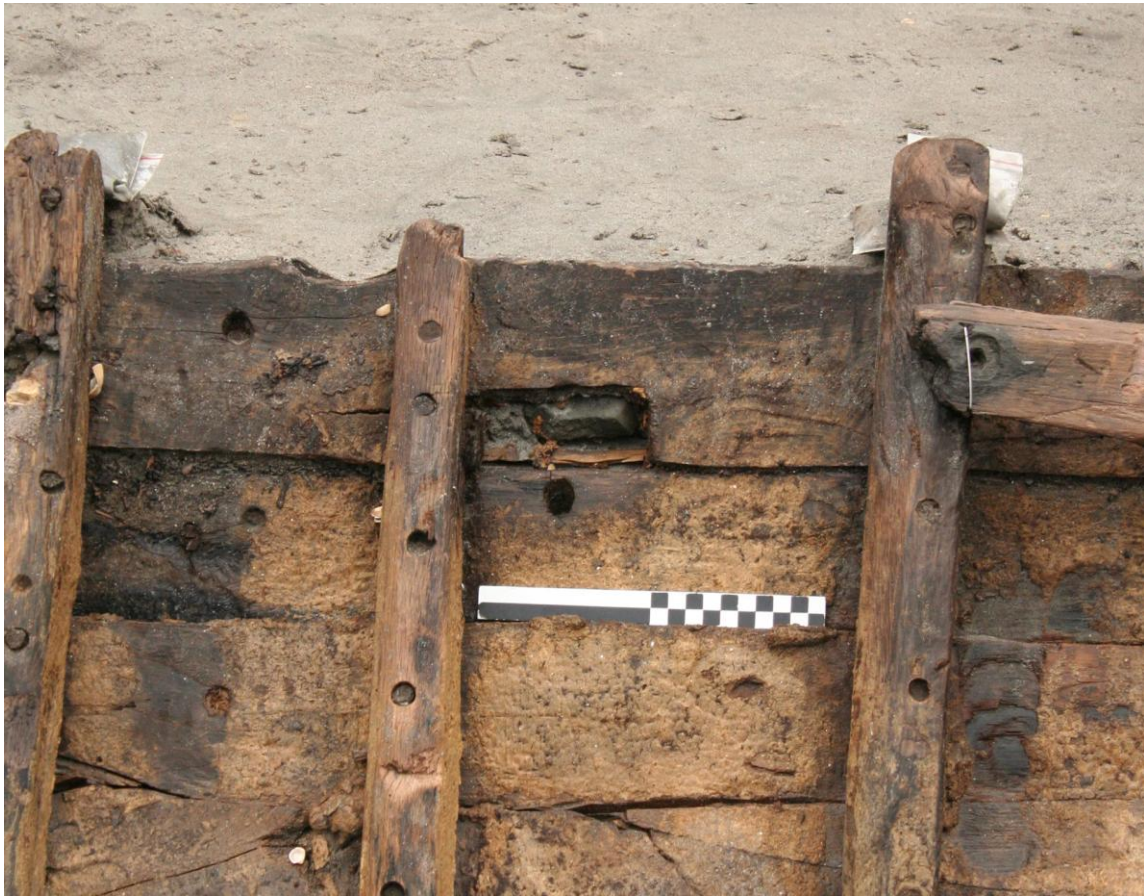
Figure 3.119: Aperture in planking revealing a through-beam location at FL 32, before the dismantling of the hull.

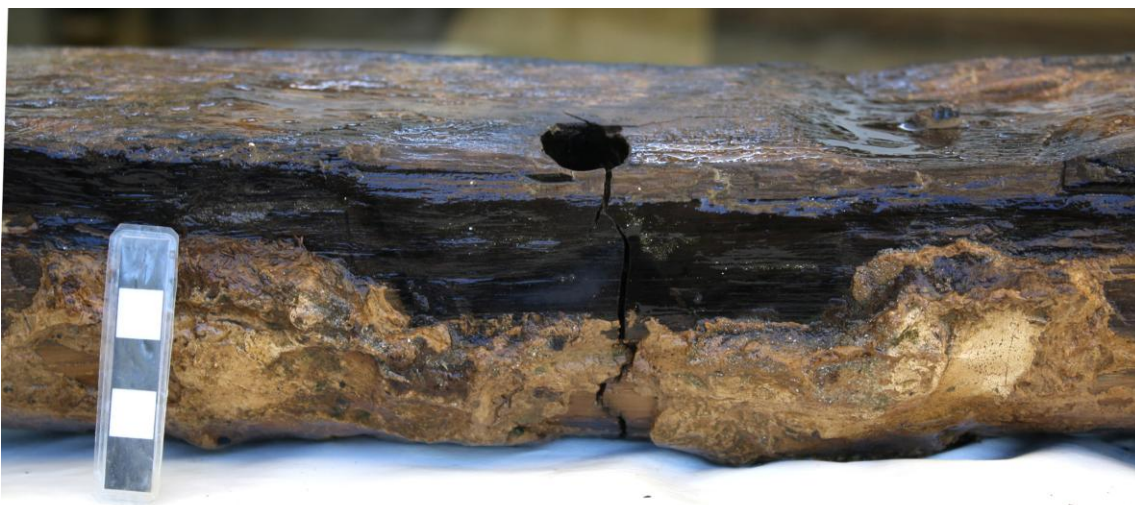
Figure 3.120: Location of a through-beam position on the upper edge of wale PS 13 at FL 32. Note the wear on the upper edge and the thick pitch deposits on the outer face of the wale.

Pitch ridges on the upper face of the wale indicate the locations where the through-beams rested on the wale and show that they protruded by at least 0.9-1.6 cm beyond the planking. The ridges seem to indicate that the through-beams did not protrude from the hull further than the wale itself. A score mark on the upper face of the wale was also found at the forward edge of the through-beam location between frames FL 31-32 (**Figure 3.123**). The score mark suggests that both through-beams were installed before plank PS 14-2/2-6. At this stage in the construction, some transverse supports inside the

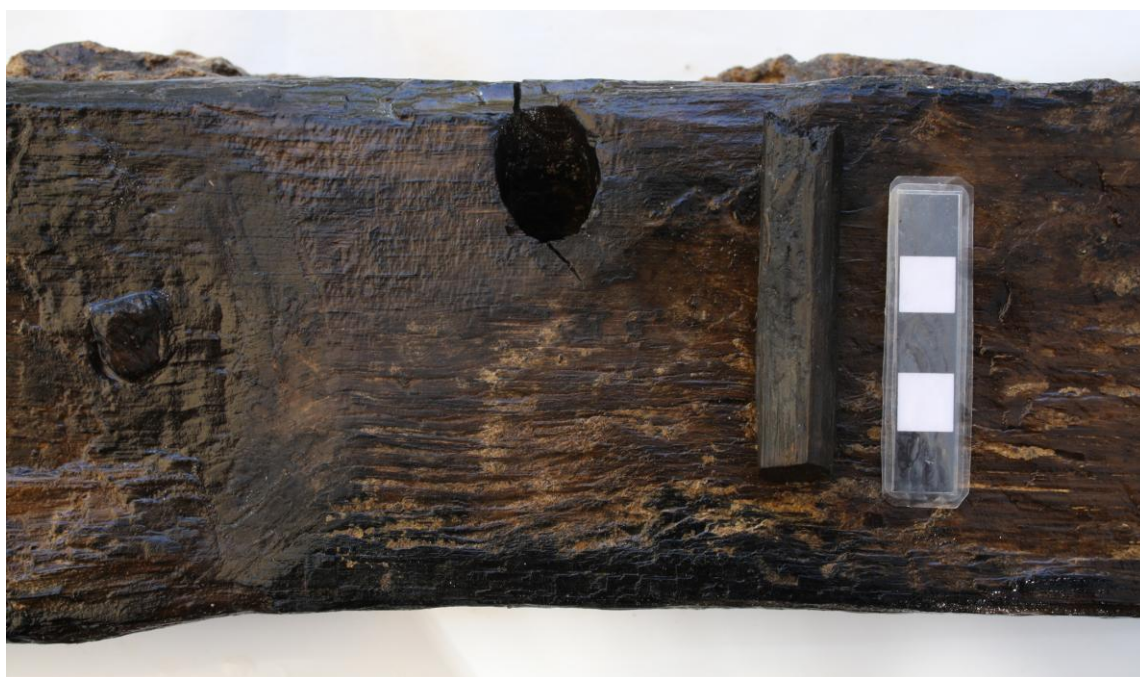
Figure 3.121: Wale PS 13, FL 32 through-beam location at FL 32. The broken treenail at right was removed from the through-beam fastener hole.

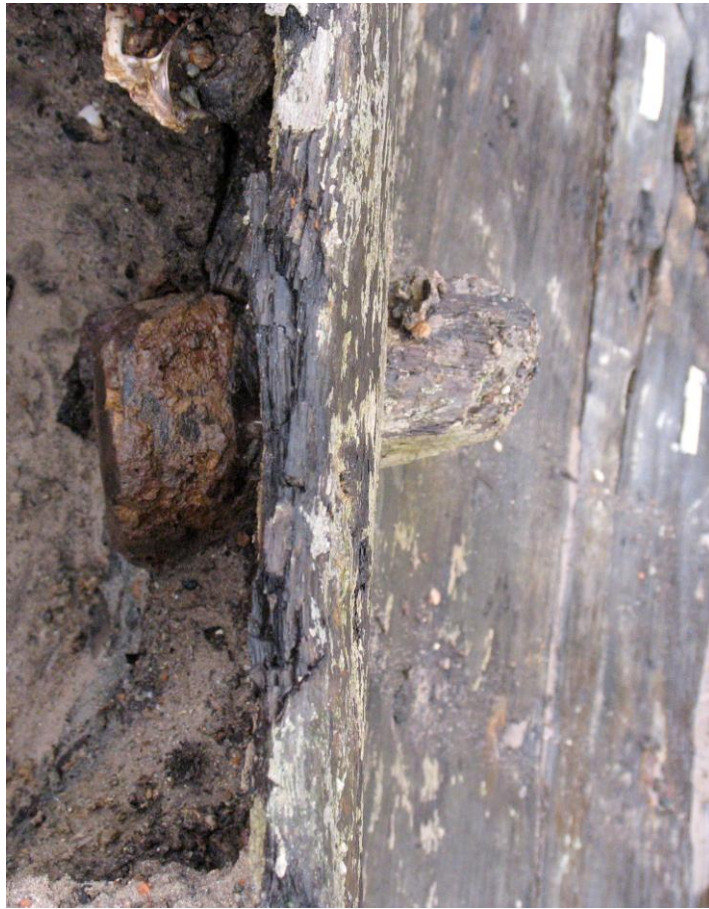
Figure 3.122: End of a through-beam in situ, from the hull of the tenth-century ship YK 5.

Although the actual timbers did not survive, evidence from the wale and the next strake above reveal the locations of at least two through-beams (**Figure 3.118**). Both rested on the upper face of PS 13—one just aft of the grooved futtock F 29 and the other just aft of the grooved futtock F 32—and were fastened to the wale with treenails driven diagonally downward through drilled holes 1.8-2.1 cm in diameter (**Figure 3.119**). No corrosion products from metal fasteners were found in either of the holes, indicating that metal fasteners were not used to secure the timbers; however, a treenail fragment 6.2 cm long and 1.2-1.3 cm in diameter was found in the fastener hole at the aft through-beam (**Figures 3.120-21**). The reason for the difference in the diameters between the treenail found in the F 32 fastener hole and the fastener holes themselves is unclear. Perhaps the original fastener had a pronounced taper, and the through-beam was designed to be held in place primarily by strake PS 14 or other fasteners: the through-beam itself could have been notched in such a way as to lock it in place in the aperture cut for it in strake PS 14, similar to the design of a through-beam used on the tenth-century wreck YK 5 (**Figure 3.122**).

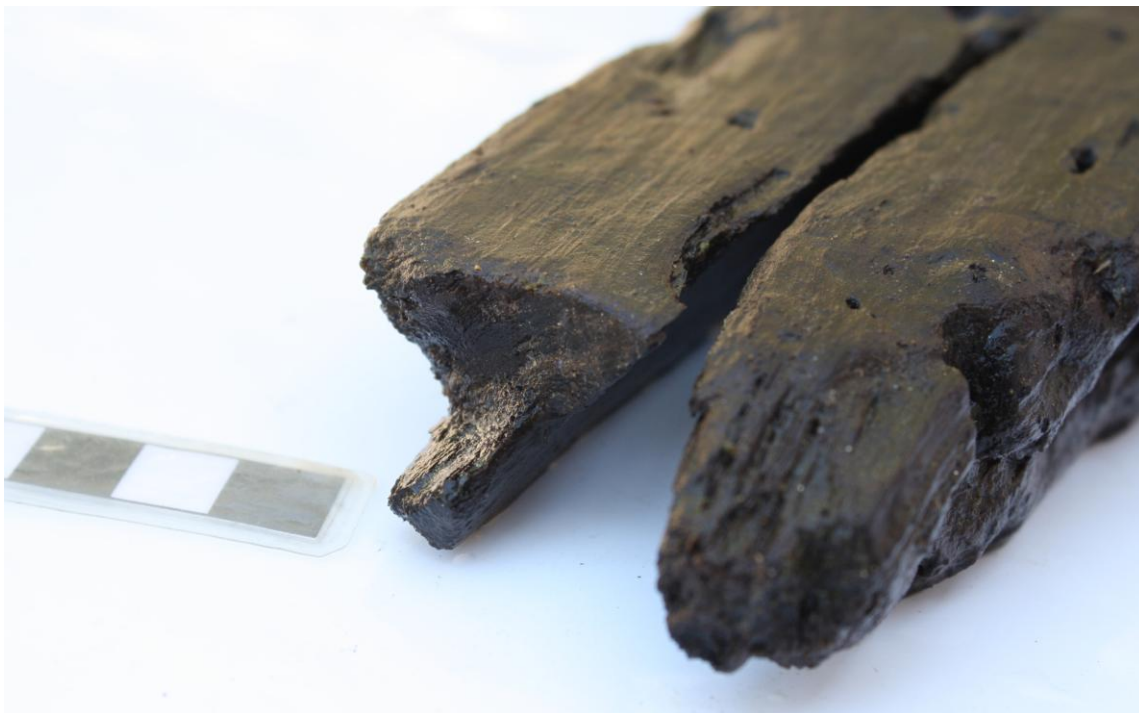
Figure 3.124: Remains of a possible drilled hole for a through-beam at aft end of wale PS 13, between frames 10 and 11.

A third possible through-beam location occurs at the broken aft end of the wale between frames 10 and 11. Although poorly preserved, the break occurs at what appears to be a partially preserved drilled hole, which is angled in the same orientation as the fastener holes at the through-beams at frames 29 and 32 (**Figure 3.124**). Through-beams would be necessary for a stern deck in this area, so a third through-beam in this location is plausible.

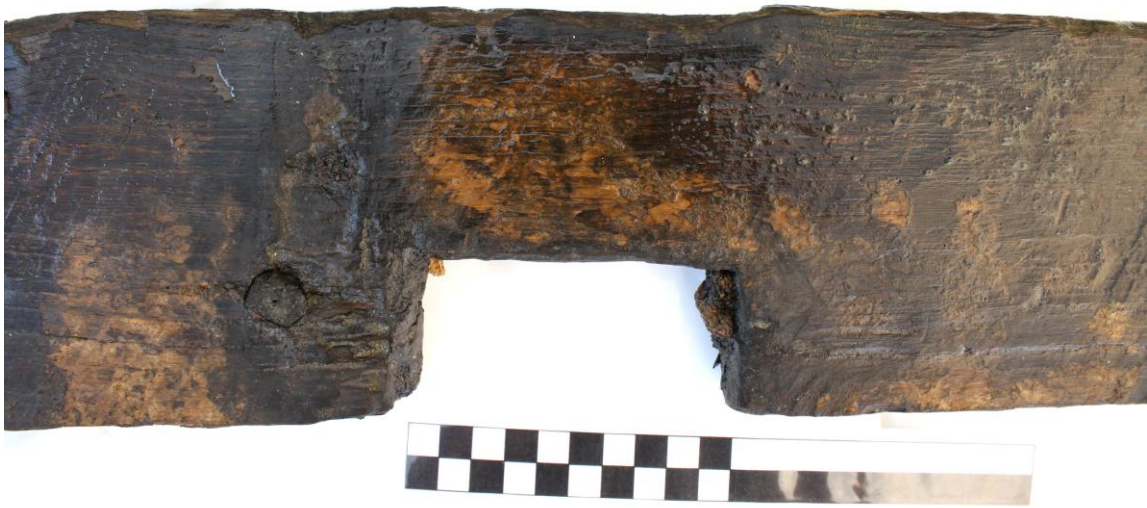
Figure 3.126: Detail of through-beam notch at F 29.

Two through-beam apertures were cut into PS 14’s lower half to accommodate the through-beams fastened to wale PS 13 (**Figures 3.125-26**). These features provide approximate cross-sectional dimensions for the original through-beams. The forward of the two apertures, located just aft of FL 32’s location, is 9.1 cm wide and 4.2-4.3 cm deep. The aft aperture was cut just aft of the location of futtock F 29; it is 8.9 cm wide

and 4.4-5.0 cm deep. The through-beam apertures were spaced approximately 66 cm apart, edge to edge. A crack in the plank, which runs from the edge of the through-beam aperture forward under the floor FL 32, was repaired with caulking in antiquity (**Figure 3.127**). Based on the edges of the apertures, each was made with two saw cuts into the inboard edge of the plank, approximately 9 cm apart, to the desired depth, after which the wood between the cuts was removed with a chisel.

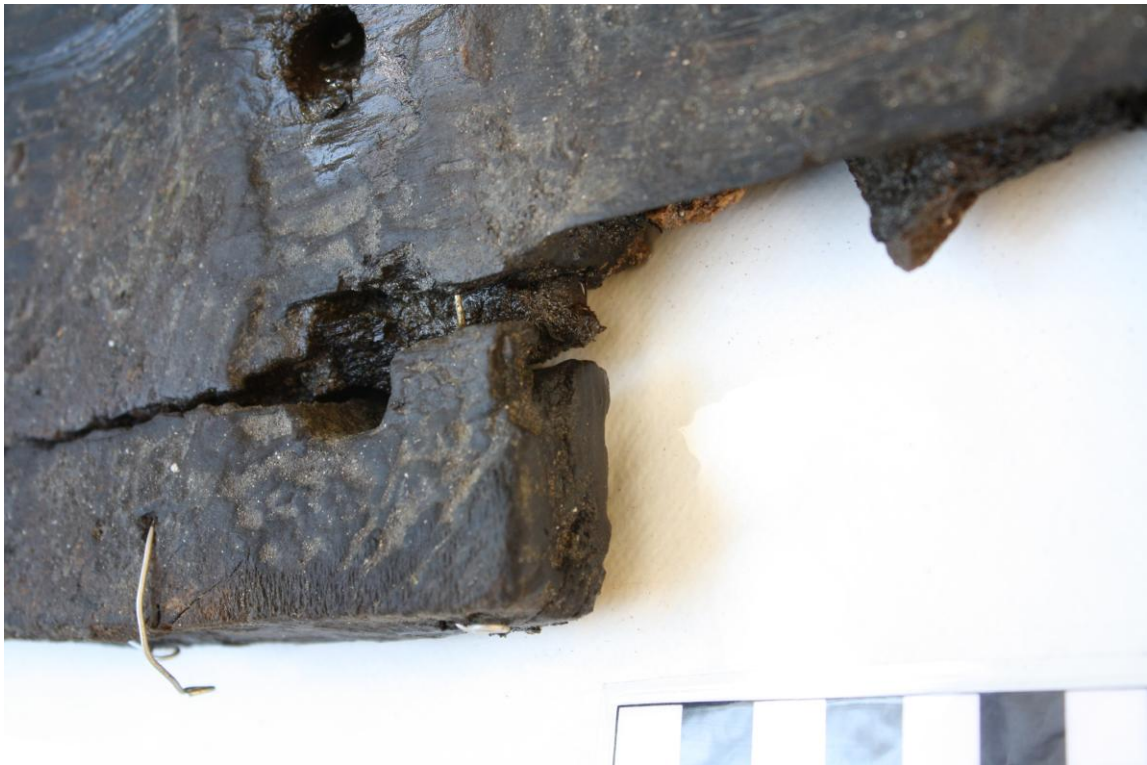
Figure 3.127: Through-beam notch on PS 14 at FL 32, showing caulking repair to old damage around the through-beam aperture.

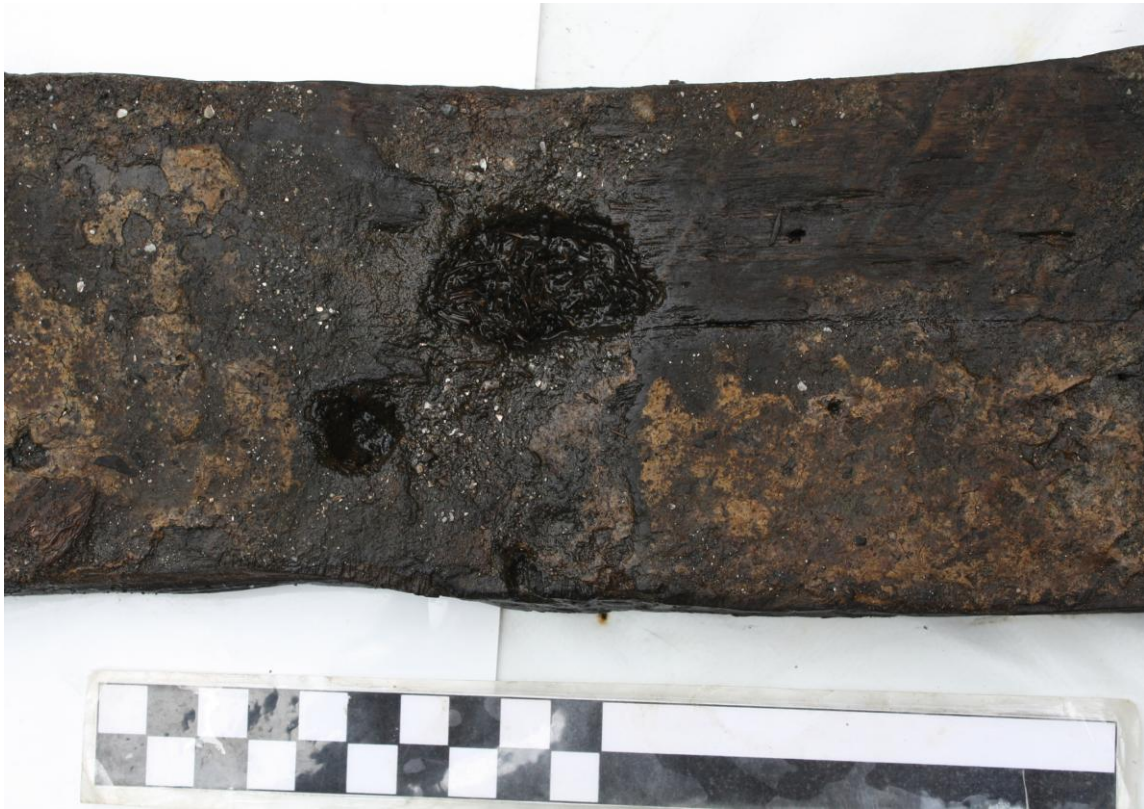
Figure 3.129: A detail of repair plank PS 6-2/2-4. The large caulked hole at center appears to be plugging a rotten treenail hole from the previous use of the plank. The treenail to the left is from the plank's use on YK 14.

Of the 12 identified replacement planks, all show evidence of previous use as hull planking. In all but one case (plank PS 11-2/6), coaks, which had been installed during the plank's previous use in another vessel, were present on the plank edges; one indication that these are repair pieces is the fact that these coaks had been cut in antiquity and did not line up with coaks on the adjacent strakes. Some coak locations on the repair pieces were clearly marked by scoring lines similar to those marking coak locations on the original hull planks. No effort was made to edge fasten the repair planks when they were installed in the hull. Repair pieces were fastened to the frames with iron nails, usually driven through drilled pilot holes, or with treenails. Thick caulking was driven into the seams around the repair planks, usually 0.5-1.0 cm thick, although some deposits were even thicker. Evidence for frame locations on the repair pieces from their previous uses are also apparent, including pressure marks from the edges of frames, areas of rot damage at the previous locations of frames, and unused fasteners or fastener holes. Original fasteners were either cut treenails—several repair planks have treenails cut through on the edge of the plank—or nail holes that had been packed with caulking and pitched over. Evidence for frame locations was covered by a heavy coating of pitch on several of the repair planks as well (**Figure 3.129**).

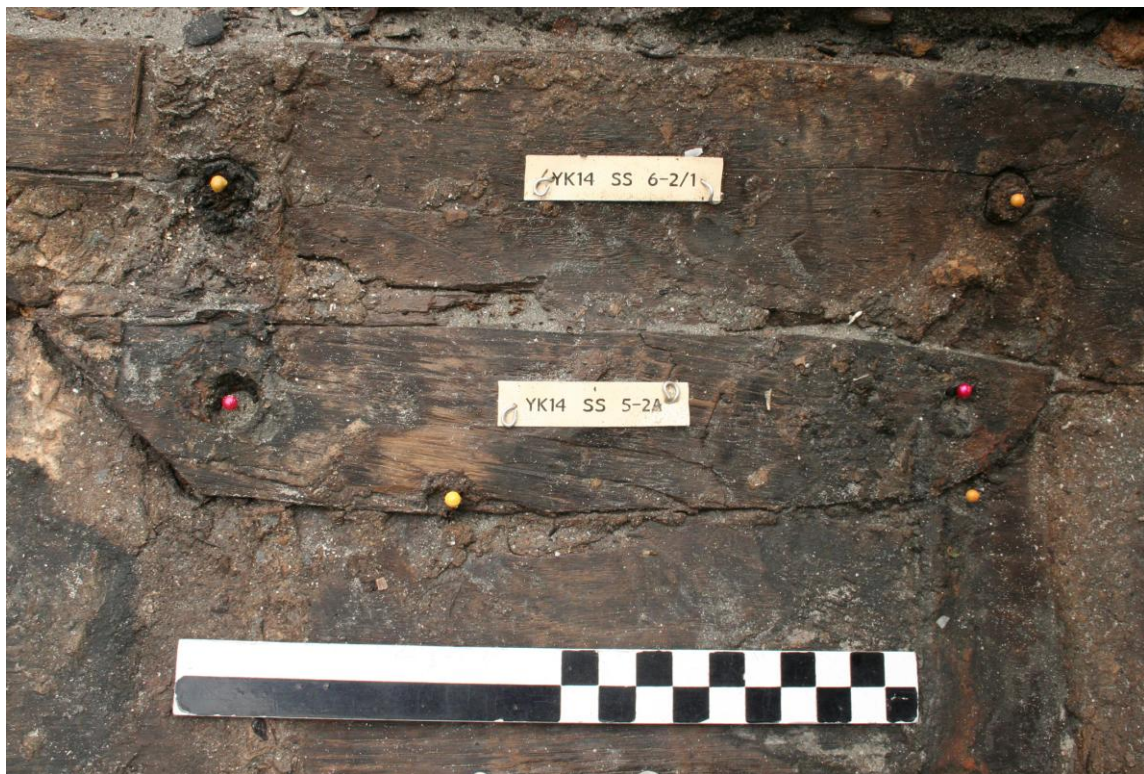
Figure 3.130: Inset graving piece SS 5-2A in situ.

Two repair planks, SS 5-2A and SS 6-2A, were inserted in the port side of the hull at the turn of the bilge. Graving piece SS 5-2A, the smaller of the starboard repair planks, is 29.4 cm in length, with a maximum width of 4.9 cm. The piece is inset into the outboard edge of SS 5-2A between FL 25 and 26 to replace a rotten or damaged area of the hull (**Figure 3.130**). Fasteners from the previous use of the plank include a single coak that was cut off on the inboard and outboard edges, and a partial treenail cut off on the plank's inboard edge. SS 5-2A was fastened to FL 25 and FL 26 with a pair of nails driven through drilled holes 1.4-1.5 cm in diameter; nail head impressions and caulking

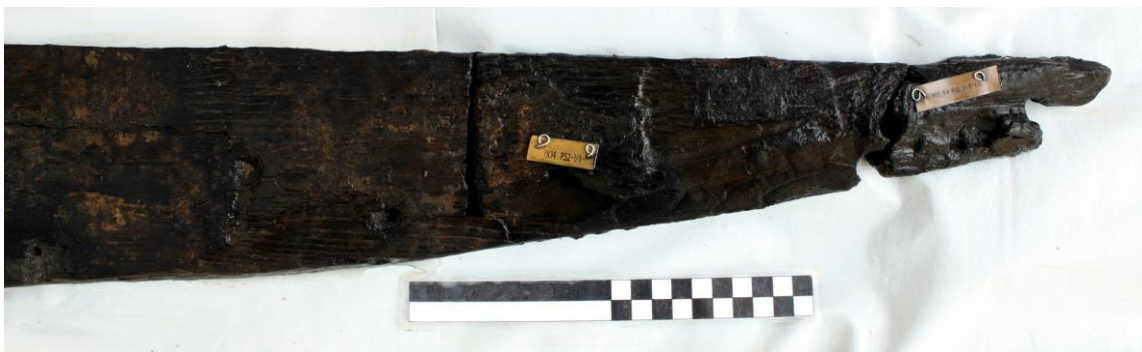
Figure 3.131: Aft hood end of PS 2-1/1-2.

More extensive repairs were undertaken on the starboard side of the ship. A large section of strake 2 was replaced in the stern area, beginning from the aft end of Keel 1 at FL 3, up to FL 11. The after-most timber, PS 2-1/1-2, is a re-used hood end plank with six fastener holes at its hood end, only three of which were used on YK 14; five frame locations from the plank's previous use are also discernible. Five coaks, including two with well-preserved score marks at their locations in the inner face, are from the original use of the plank, as are two caulked holes and treenails between FL 6-7 and FL 7-8, which appear to be frame fasteners from the previous use of the plank on a different ship.

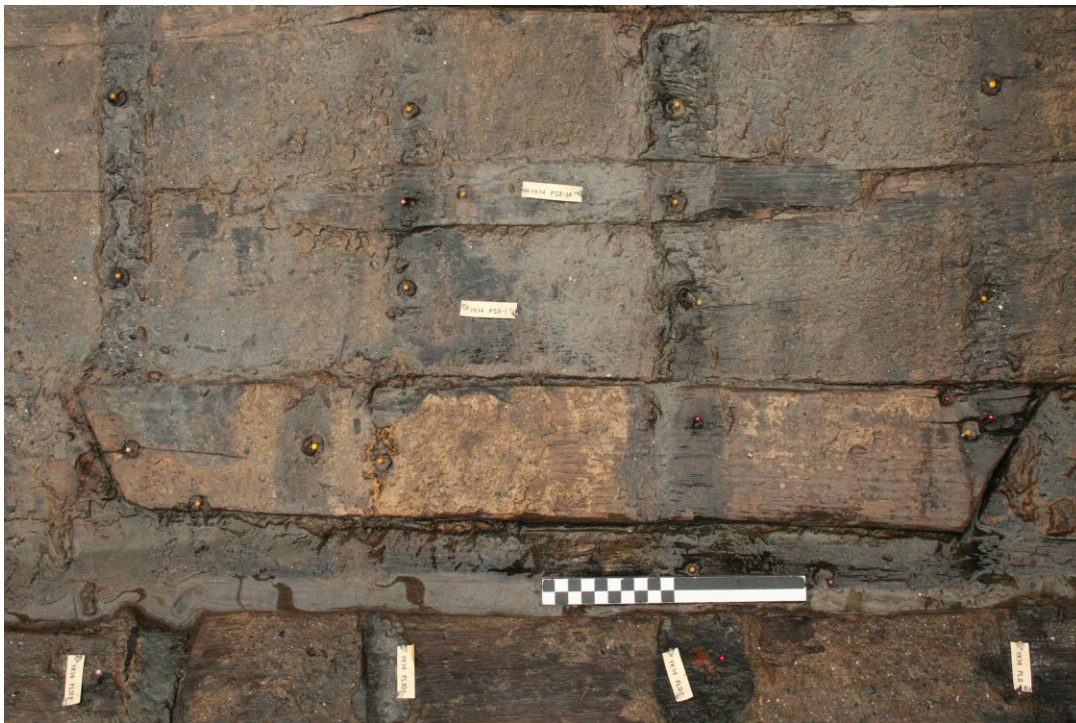
Figure 3.132: PS 2-1/3 and PS 3-1A in situ.

PS 2-1/3 is a second repair piece added to the hull between FL 8-11, terminating in short diagonal scarfs at each end (**Figure 3.132**). Two coaks, one on the inboard and one on the outboard edge of the plank, a caulked drilled hole under FL 9, treenails for frame fasteners between FL 9-10 and FL 10-11, and a partial treenail cut off on the inboard

PS 3-1A (also shown in **Figure 3.132**) is a small filler or graving piece added to the PS 2-PS 3 seam to repair what was probably a rotten area; two cut coaks (one with a score mark) on its edges indicate that the piece was obtained from a previously used plank. PS 3-1A was fastened to FL 9 with a treenail and FL 10 with a nail. A treenail between FL 9 and FL 10 and a partial treenail cut off on the keel-side edge of the plank between FL 8 and FL 9 are frame fasteners from the previous use of the plank.

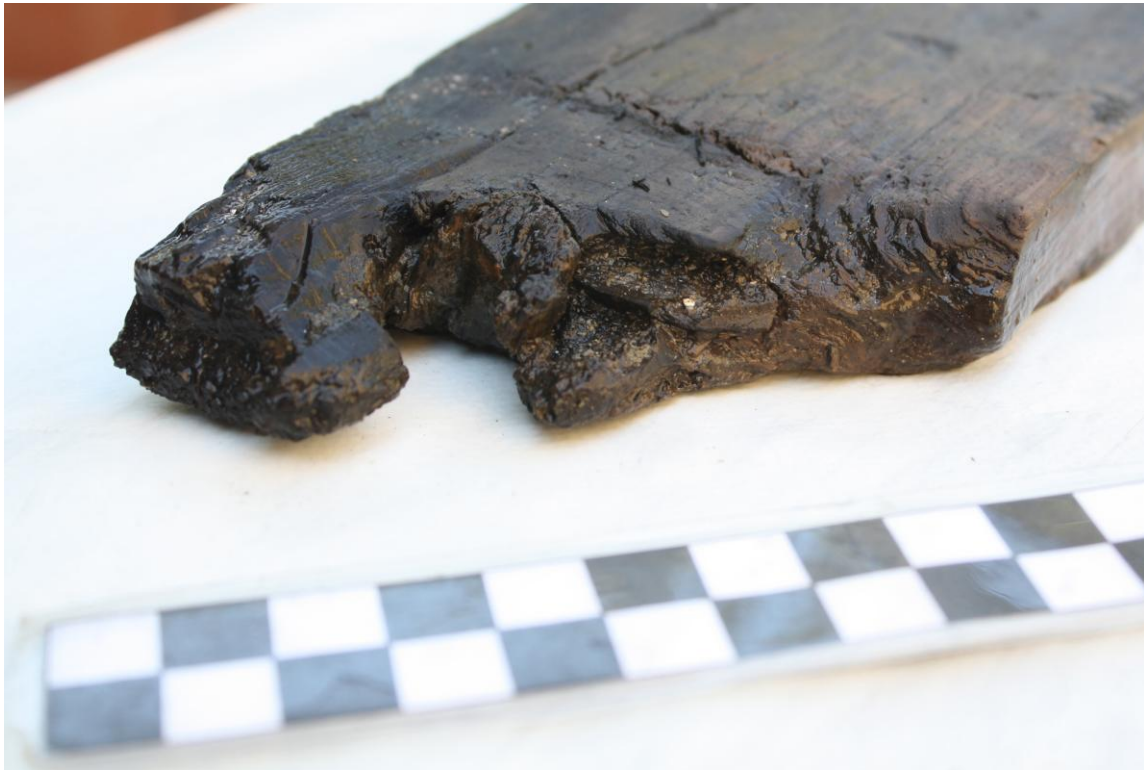
Figure 3.133: The dry rot-damaged forward end of PS 5 on the PS 5/PS 5-2 scarf edge. PS 5 was trimmed down in this area to install replacement plank PS 5-2.

As with the port side of the ship, the most extensive repairs occur in the area of the turn of the bilge on the starboard side. These include the repair planks PS 5-2, PS 5A/1-1A, PS 6-2/1, and PS 6-2/2-4. PS 5-2 is a 108.4 cm-long, narrow filler piece with a maximum width of 7.3 cm at its aft end. It was cut to shape from a previously used plank and inserted between FL 36 and FL 40; it is somewhat worn and appears to have been slightly compressed in some areas. Damage from wood rot is clearly apparent at the forward end of PS 5, an indication for the reason for PS 5-2's insertion (**Figure 3.133**). Four coaks from the original use of the plank—three on the outboard edge and one on the inboard edge—were cut in antiquity before the plank's re-use in YK 14. Two treenails, which were cut off on the inboard edge of the plank between FL 38-39 and FL 39-40, as well as a partial treenail in the aft scarf edge at FL 36 and two treenails in the location of FL 37, are from four frames fastened to the plank during its original use. PS 5-2 was fastened to YK 14's frames with nails at FL 37, FL 39, and FL 40, and with a

treenail at FL 38. Caulking around the plank's edges was poorly preserved, with only a few patches and fibers remaining; perhaps the plank is an older repair to the hull.

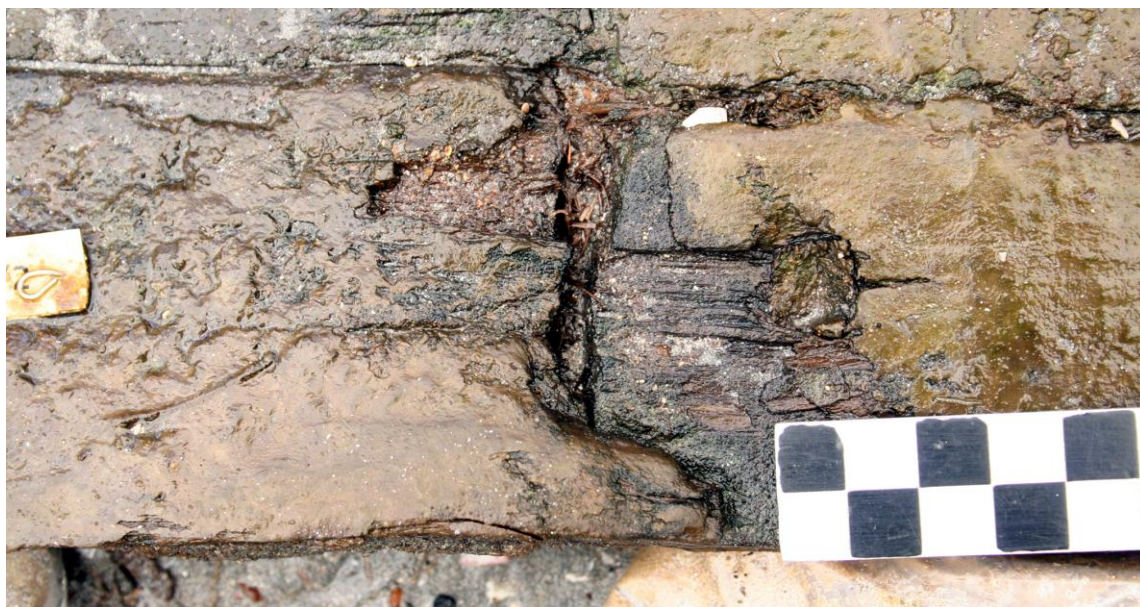
Figure 3.134: Inner face view of the repair 'scarf' between PS 5A/2-4, an original plank which was cut out due to wood rot under the frames (left), and PS 5A/1-1A, a repair plank (right). Note the irregular edge on PS 5A/2-4 due to the damage from rot.

PS 5A/1-1A is a similar repair piece inserted between FL 19 and FL 23 (**Figures 3.134-35**). Damage from rot is clearly apparent on the forward scarf of the badly worn adjacent plank, PS 5A/2-4. PS 5A/1-1A is fastened to the frames only with treenails. Evidence for two coaks from the previous use of the plank was found on the plank's edges, as well as a caulked fastener hole and a partial treenail on the plank's inboard edge. Caulking between 0.2-0.7 cm thick was found on the plank's seams and was especially well

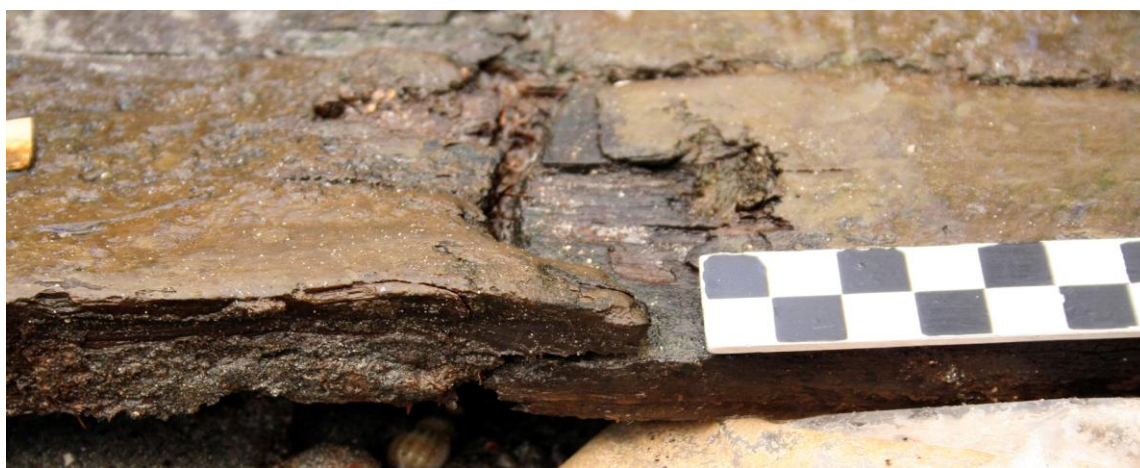
Figure 3.135: View of the inboard edge of the seam between PS 5A/2-4, an original plank damaged by rot (left), and the repair plank PS 5A/101A (right).

preserved along its outboard edge. This is in marked contrast to the poorly preserved caulking along the seams of the original section of the strake, PS 5A/2-4.

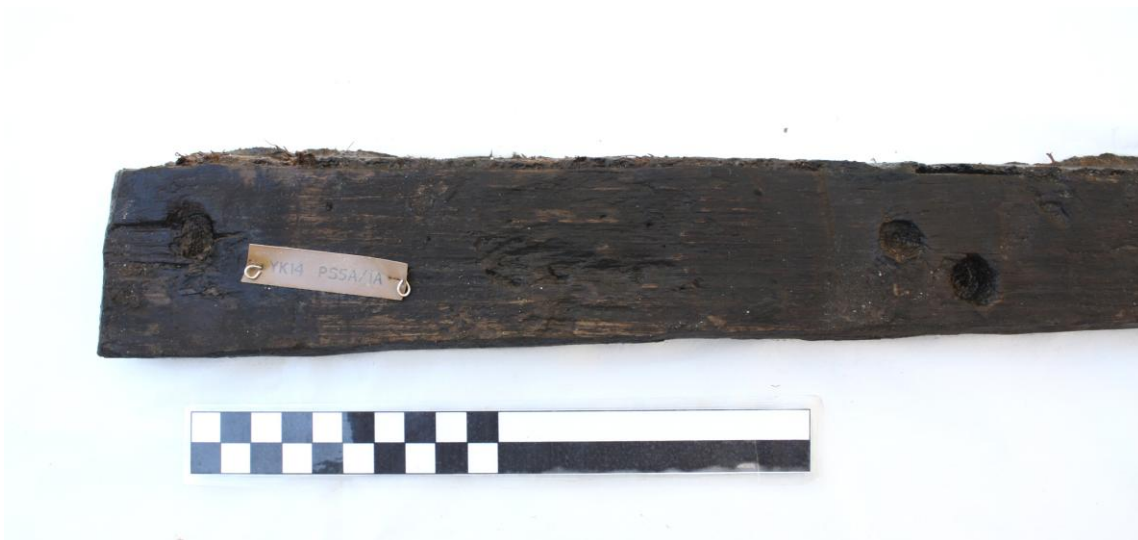
Figure 3.136: Forward scarf end of PS 5A/1-1A.

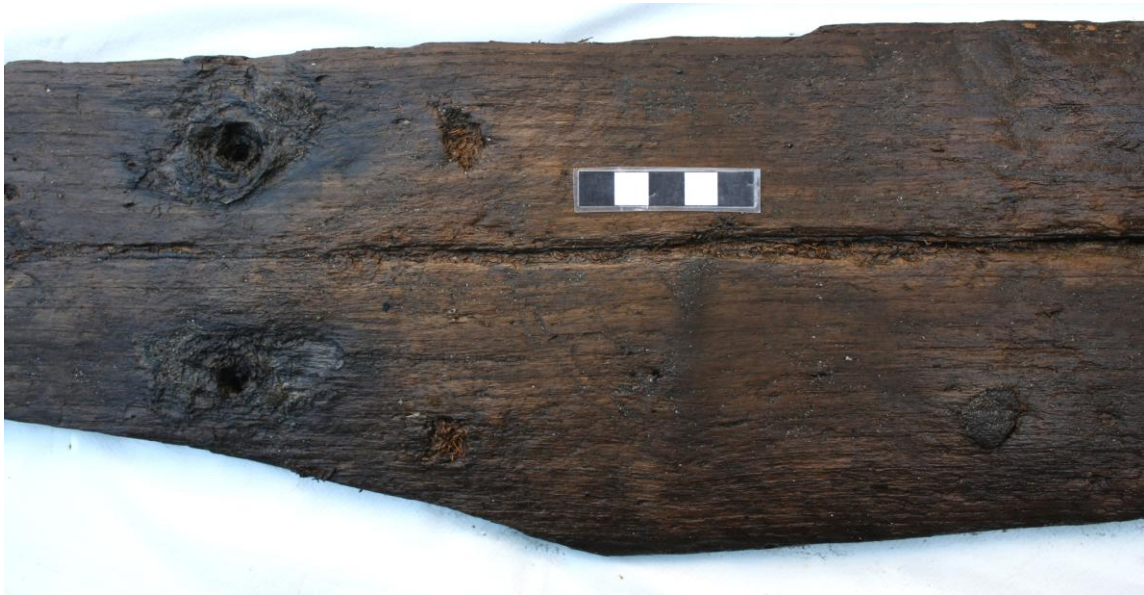
Figure 3.137: A caulked split along the outer face of PS 6-2/2-4.

A large section of PS 6 between FL 24 and FL 32 was replaced with two repair planks. The aft repair plank, PS 6-2/1, is a small filler piece replacing a damaged end of a diagonal scarf nailed to the frames FL 24 and FL 25. PS 6-2/2-4, which runs between FL 25 and FL 32, is a somewhat worn, recycled plank piece with evidence for six frame locations from its previous use in the form of fasteners and damage from wood rot, much of which was later pitched over.³⁶⁰ Drilled holes for coaks and cut coaks were found along the plank's edges; the locations of four coaks had been marked by scoring, which were discovered under the pitch on the plank's inner face. A split along the center of PS 6-2/2-4 (the pith of the original timber) was found to be heavily worn and was repaired with caulking in antiquity (**Figure 3.137**). Although both pieces could have been

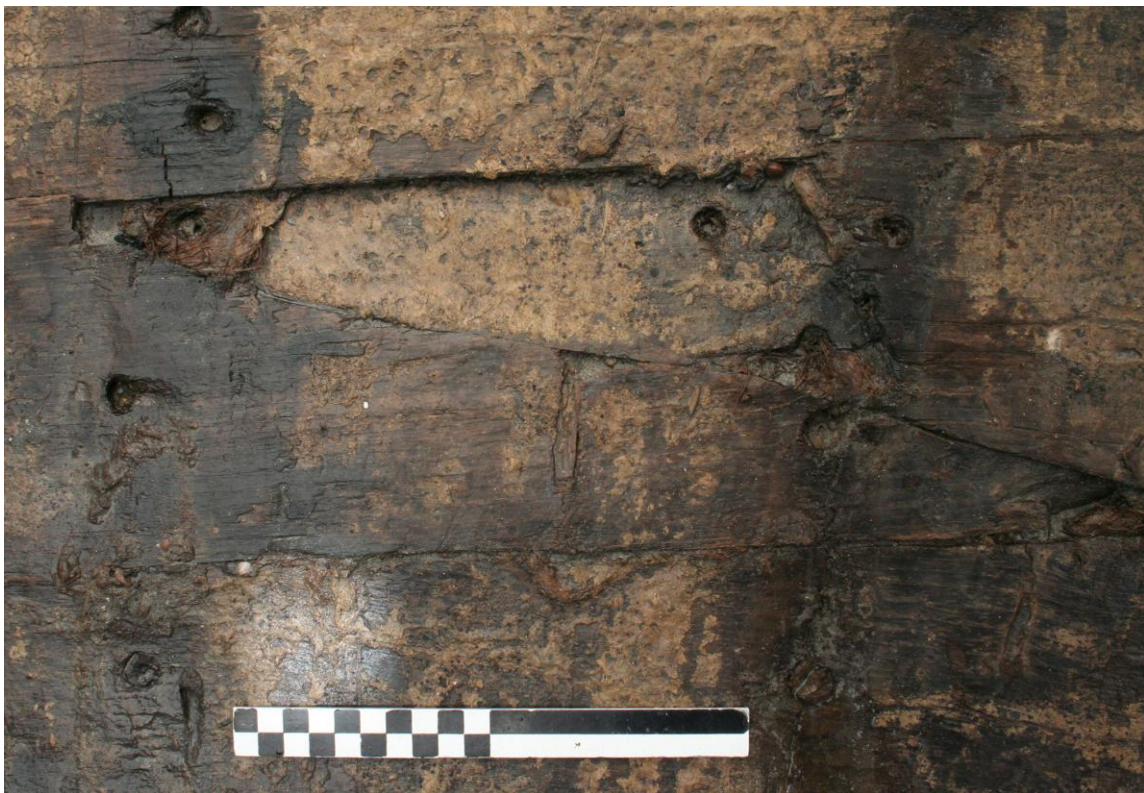
Figure 3.138: PS 9-2/5 in situ, with a caulked repair around the treenail hole at FL 35.

PS 9-2/5 is a filler piece used to replace a rotten area in the forward scarf of PS 9-2/1-4 (**Figure 3.138**). The irregular surface on the forward scarf end of PS 9-2/1-4 is clearly due to damage from wood rot. The aft end of the plank appears to have been held in place by a nail driven into the edge of the scarf seam between PS 9-2/1-4 and PS 9-2/5, and a treenail in the aft end of the piece at F 35. Caulking on the inner face of the filler

piece around FL 35 indicate that it was an area of leakage, which required repairing, probably due to a longitudinal crack in the edges of the plank around a treenail hole. A single coak from the original use of the plank was found on the upper edge of PS 9-2/5, as well as evidence of frame fasteners from its previous use, including a pitched-over partial drilled hole in its lower edge and a second cut treenail near the aft end of the filler piece between FL 34-35.
